CHEADLE LAKE

Current and Future Project Status

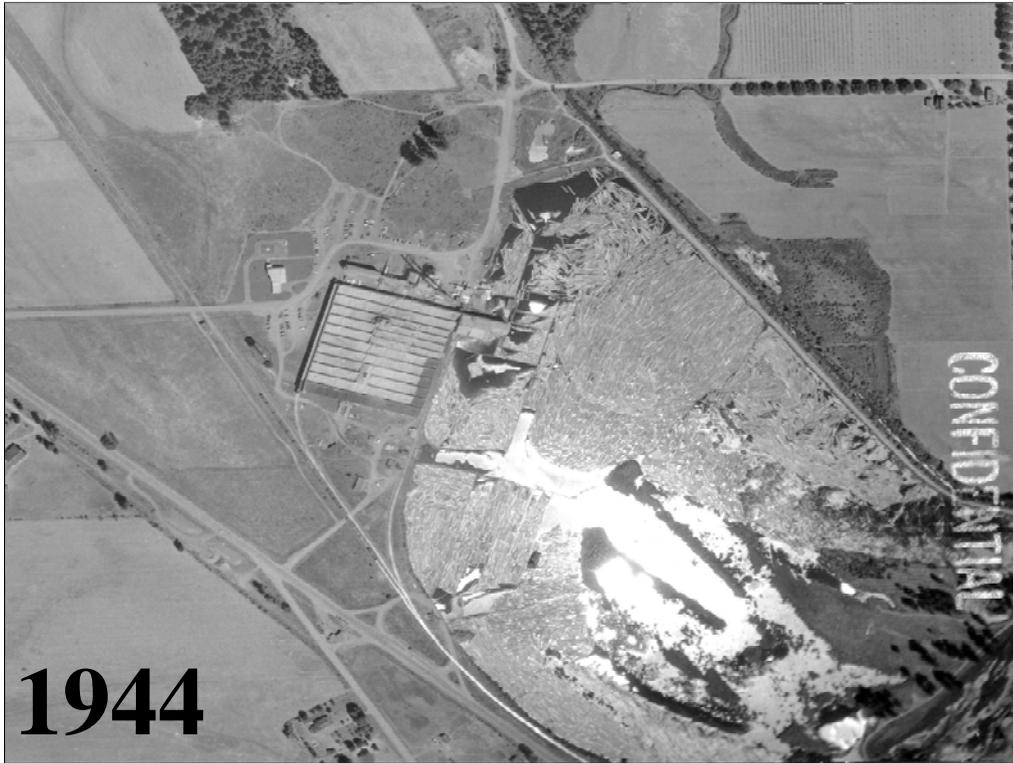
- Transition from pasture to mill pond begun in August 1940.
- Note that initially the lake water surface elevation was matched to the canal water surface elevation
- This was phase one – the large northwestern segment of the berm up to what is now the island access road. Vegetation was cleared and existing soil was excavated and pushed up onto the bank of the canal.
- Staff has never found record of any water right issued to the mill for use of Santiam River water (from the canal) to maintain the lake level for industrial use
- Note the concerns with the potential impacts of ground water connection through the bottom of the lake

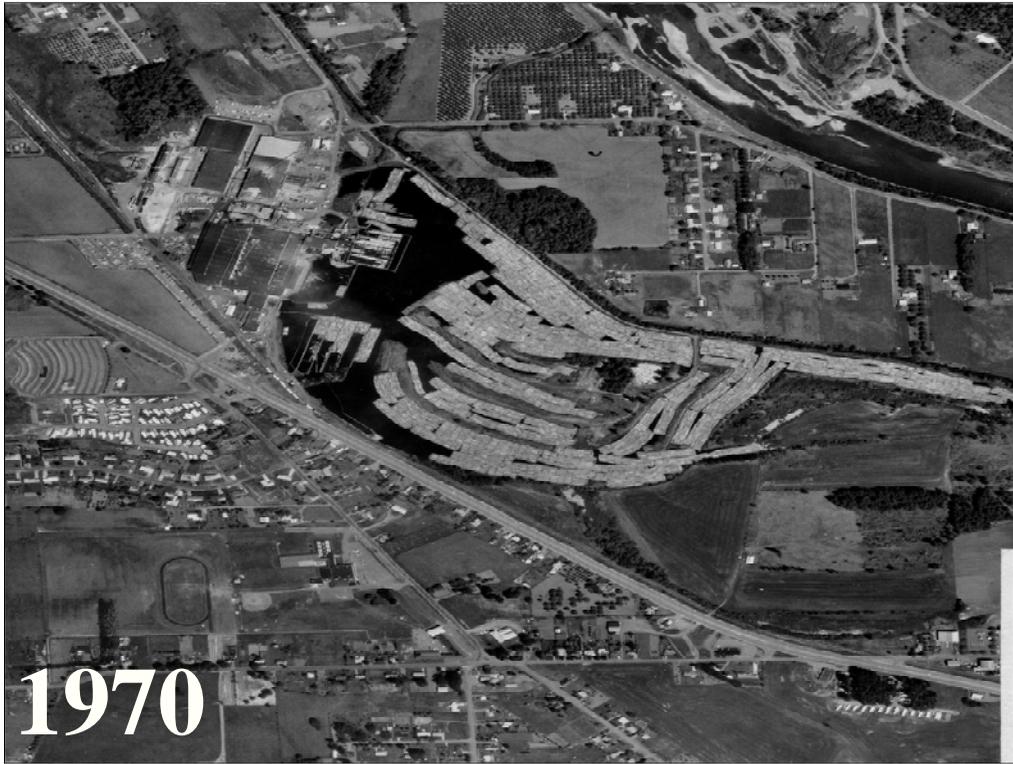
- Mill pond full of log rafts
- Note raft in NW corner of lake feeding green chain to mill

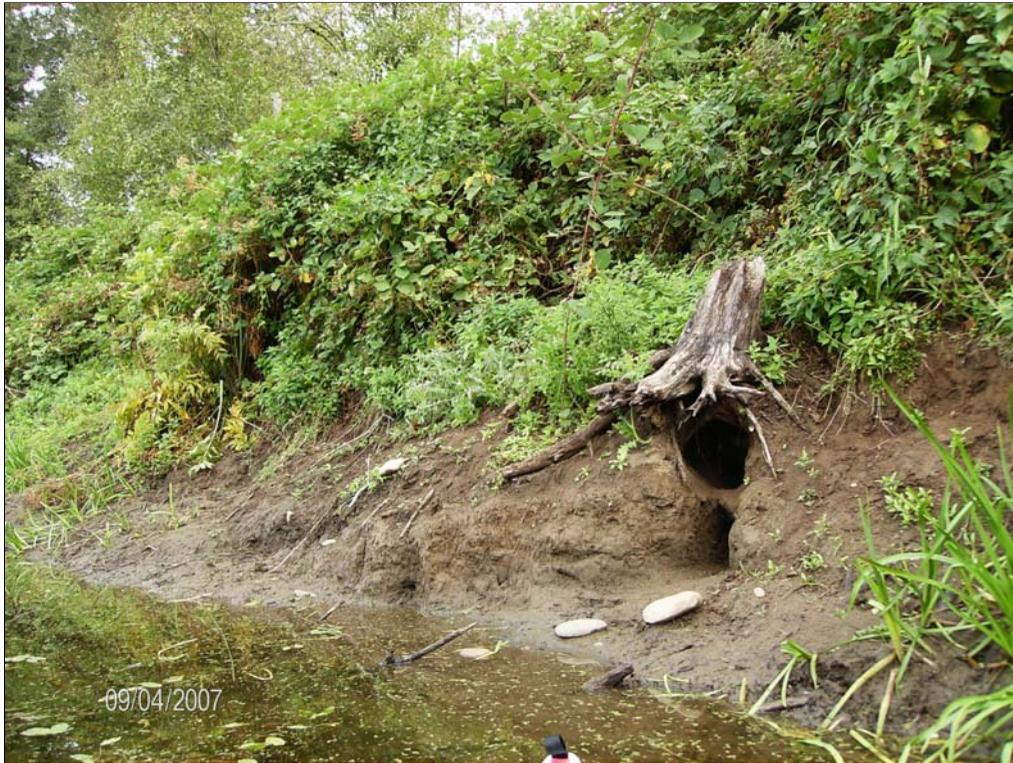
- Cross section diagram of existing conditions and known issues at North Shore berm segment
- Note that the canal now operates on a seasonally adjusted volume that corresponds to City of Albany’s hydro-generation operating permit. The canal water surface elevation varies by as much as 3 to 5 feet during warm weather (low flow volume) months (typically June through October-November)
- Berm structural issues:
 - Non compacted, non structural fill material
 - Through and Through vegetation root intrusion
 - Base ‘soil piping’ directly connected to canal at canal flow line
 - Animal burrows and activity impacts
 - Canal erosion at berm base (geometry of berm plus water dynamics)
 - Lake level relative to canal operating level and hydraulic pressure on berm

- Decision made to begin lowering lake water surface level to reduce pressure on lake side of the berm
- Sought input and proposal from geotechnical engineering consulting firm for evaluation and recommendations. Issues are time to complete evaluation, make recommendations, prepare design options for repairs and ultimate rehabilitation costs.

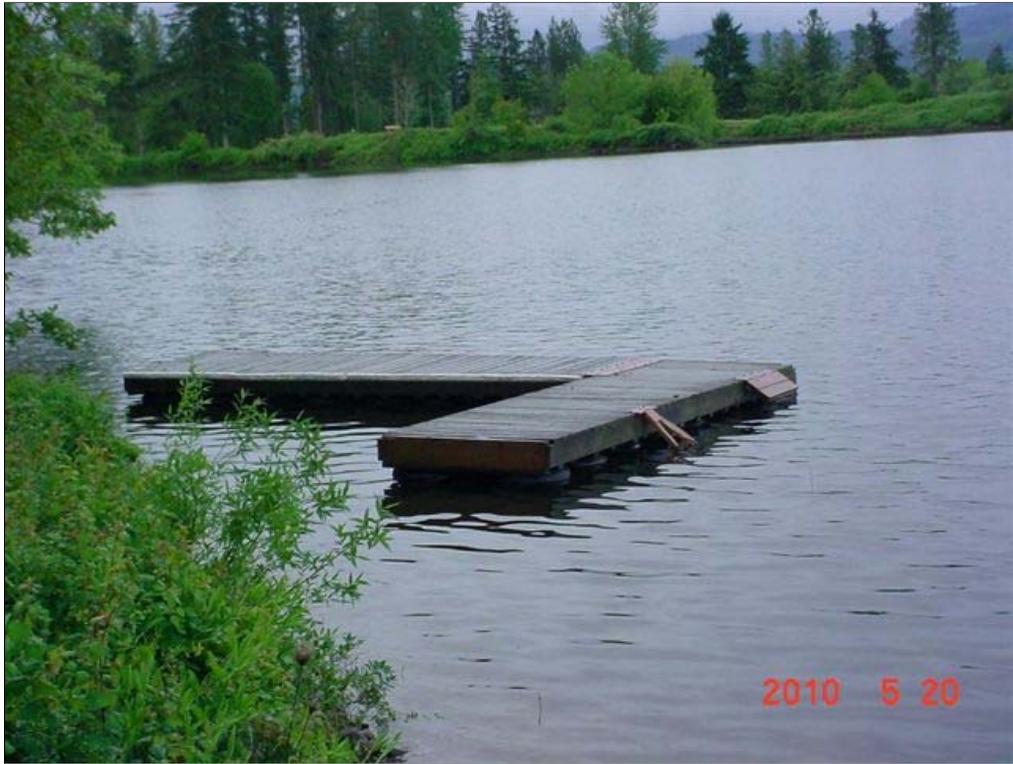
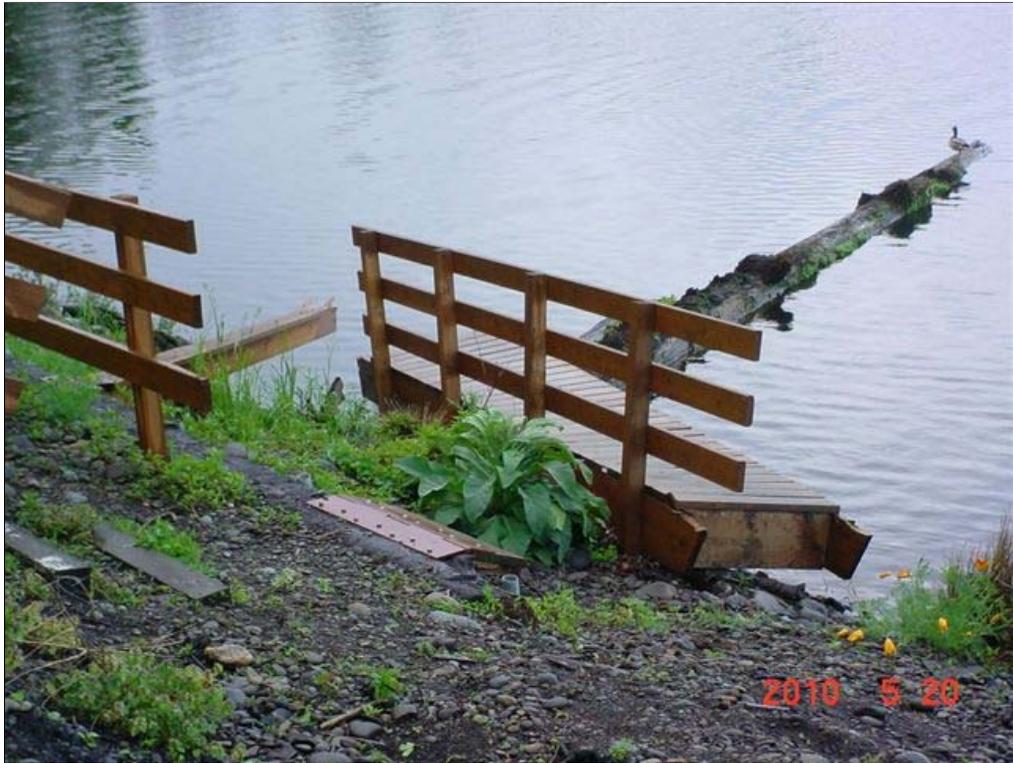
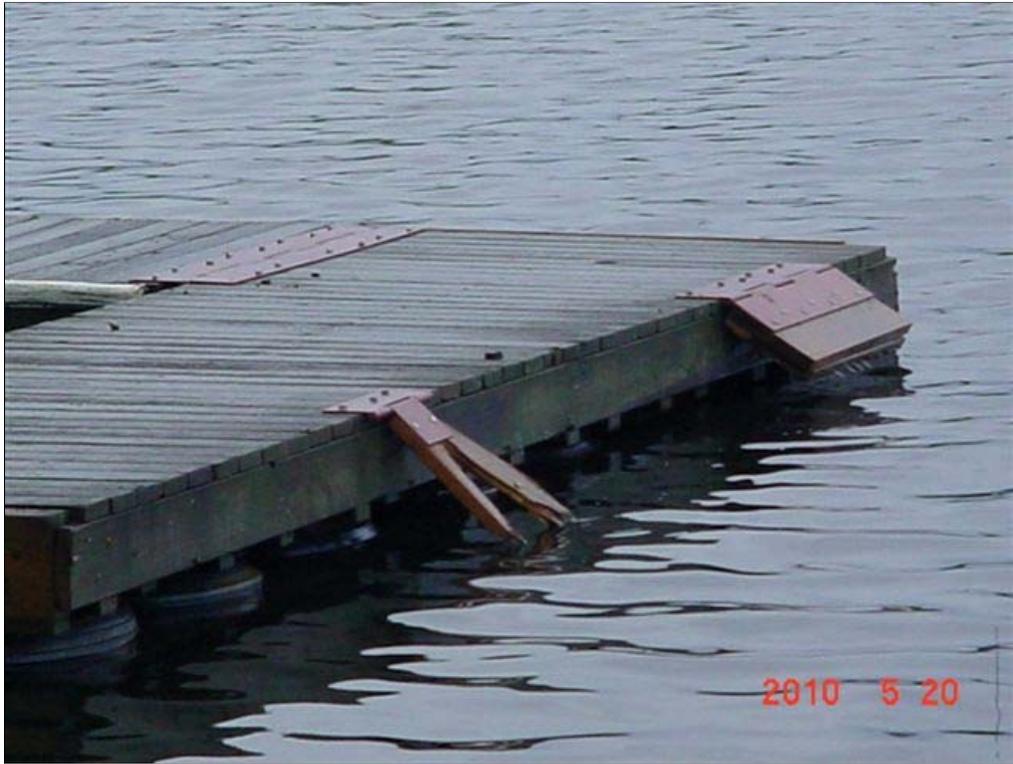
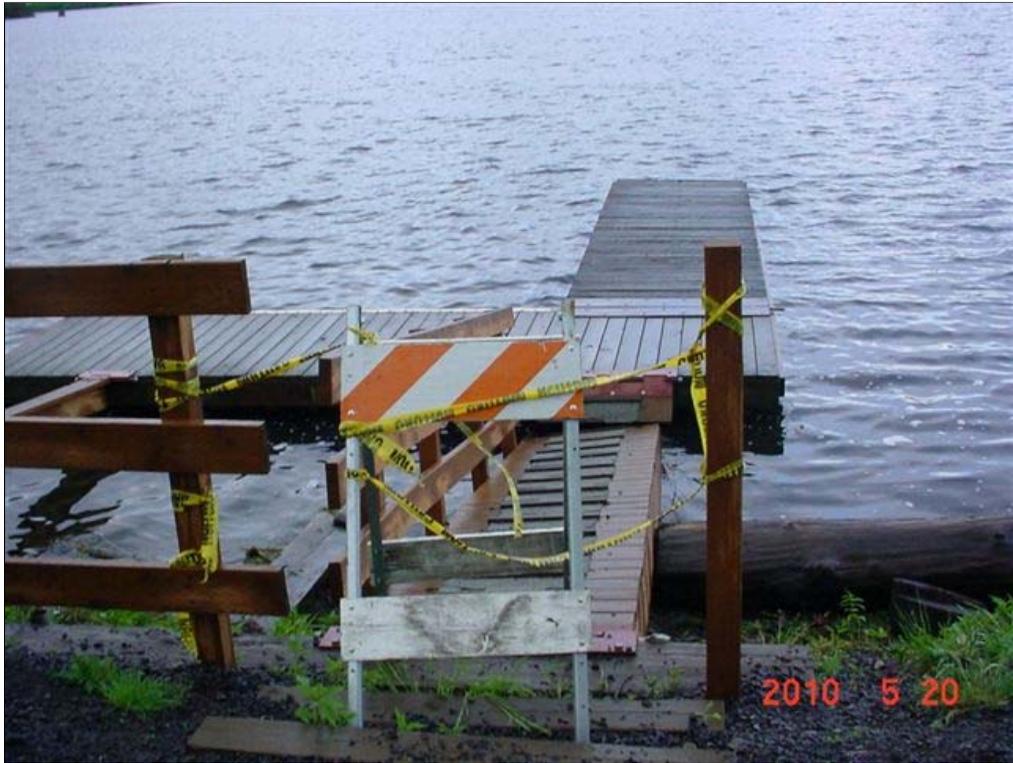
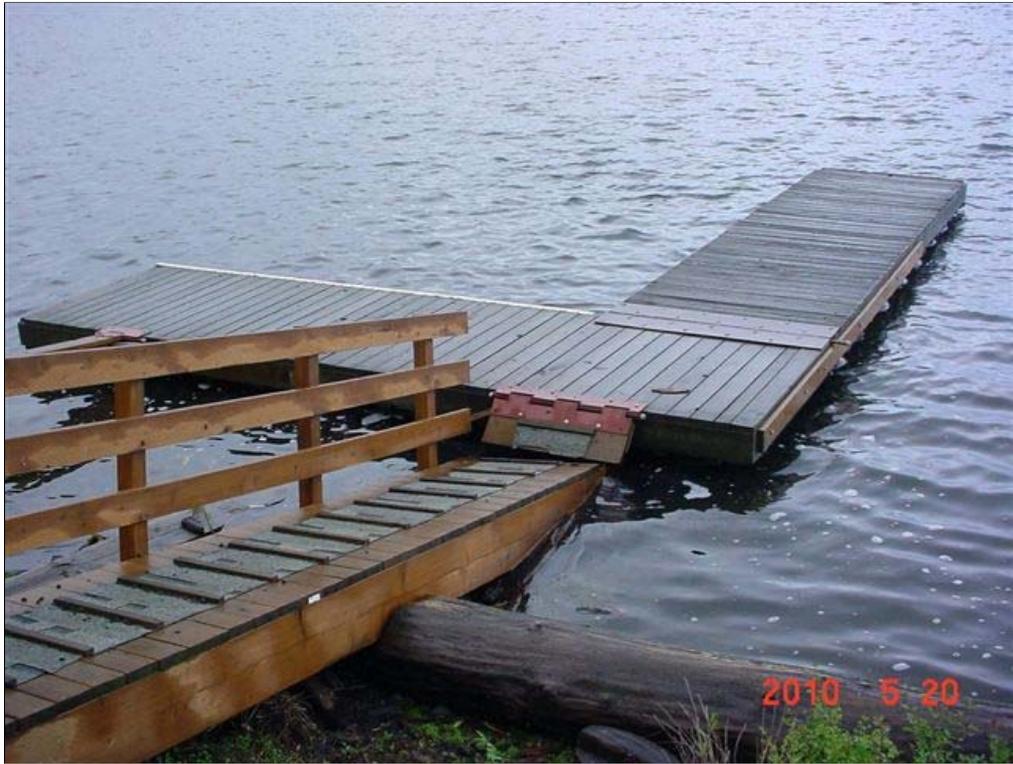
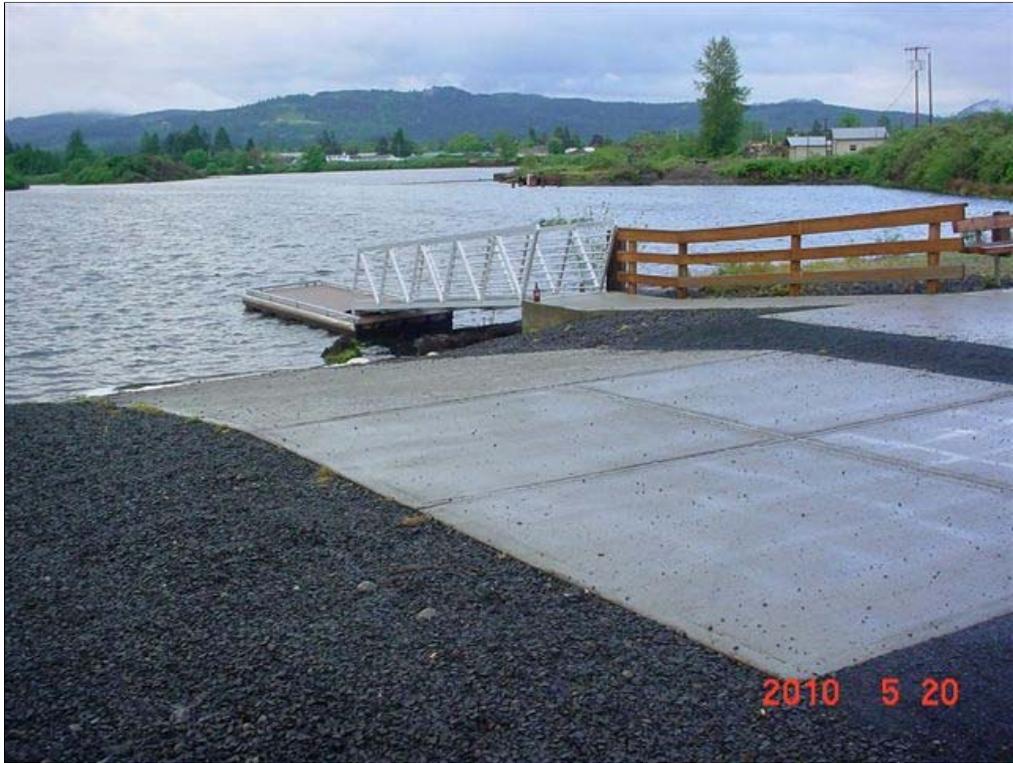
- Constructed by NW Steelheaders 2009 with City maintenance staff site prep assistance
- Two fishing docks – floating dock sections came from dock replacement project by Corps of Engineers
- Limited mobility access fishing platform
- Boat ramp and dock – needs piling installed for wind resistance
- May 2 wind storm damage and wind impacts on remaining structures

- Structural assessment of wind damage;
- Needs professional engineer design solutions and stamped set of drawings with construction oversight (liability limitation issue and building code compliance)
