STATE OF OREGON INVENTORY  
OF HISTORIC PROPERTIES  
State Historic Preservation Office  
Oregon State Parks, Salem, OR 97310

County Linn  
Ranking \_\_\_\_\_  
Name  
(Common) Church of Christ  
(Historic) Baptist Church  
Address 210 East Grant Street  
Present Owner Church of Christ  
Address 210 East Grant Street  
Original Use Church  
Date of Construction 1891  
Map Reference Number 50

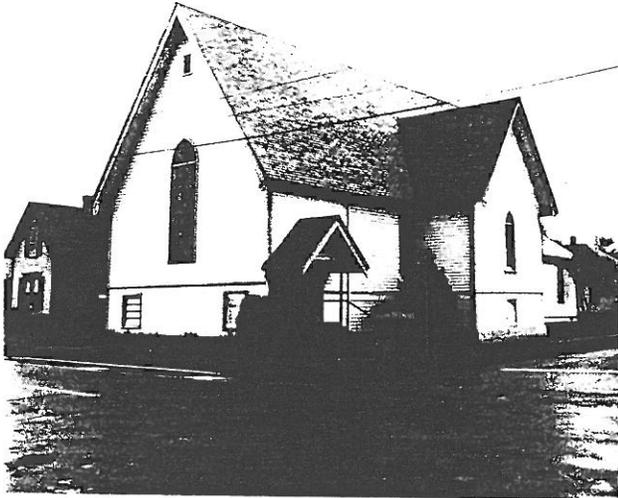
The plan for this Gothic Revival church is a cross, with additions at both ends of the nave. The building, oriented north-south, has steeply pitched gables and is clad with horizontal siding and corner boards that have simple capitals. The barge boards have bull's eye decorations at the bottom corners. The original stone foundation is evident along the middle of the nave on the west elevation, but it has been replaced with concrete elsewhere. A belt course separates the church's meeting hall on the first floor from the raised basement.

New double doors with glass block sidelights and a gable roofed entry porch are located at the northwest corner. The transept's gable end on the west elevation contains a double-hung pointed arch window with two colored glass lights per sash, and a transom. To the left is a similar arched window with colored glass and to the right are two more, one with a rectangular frame and the other arched. The double doors in the southwestern corner of the base have three panels and single lights.

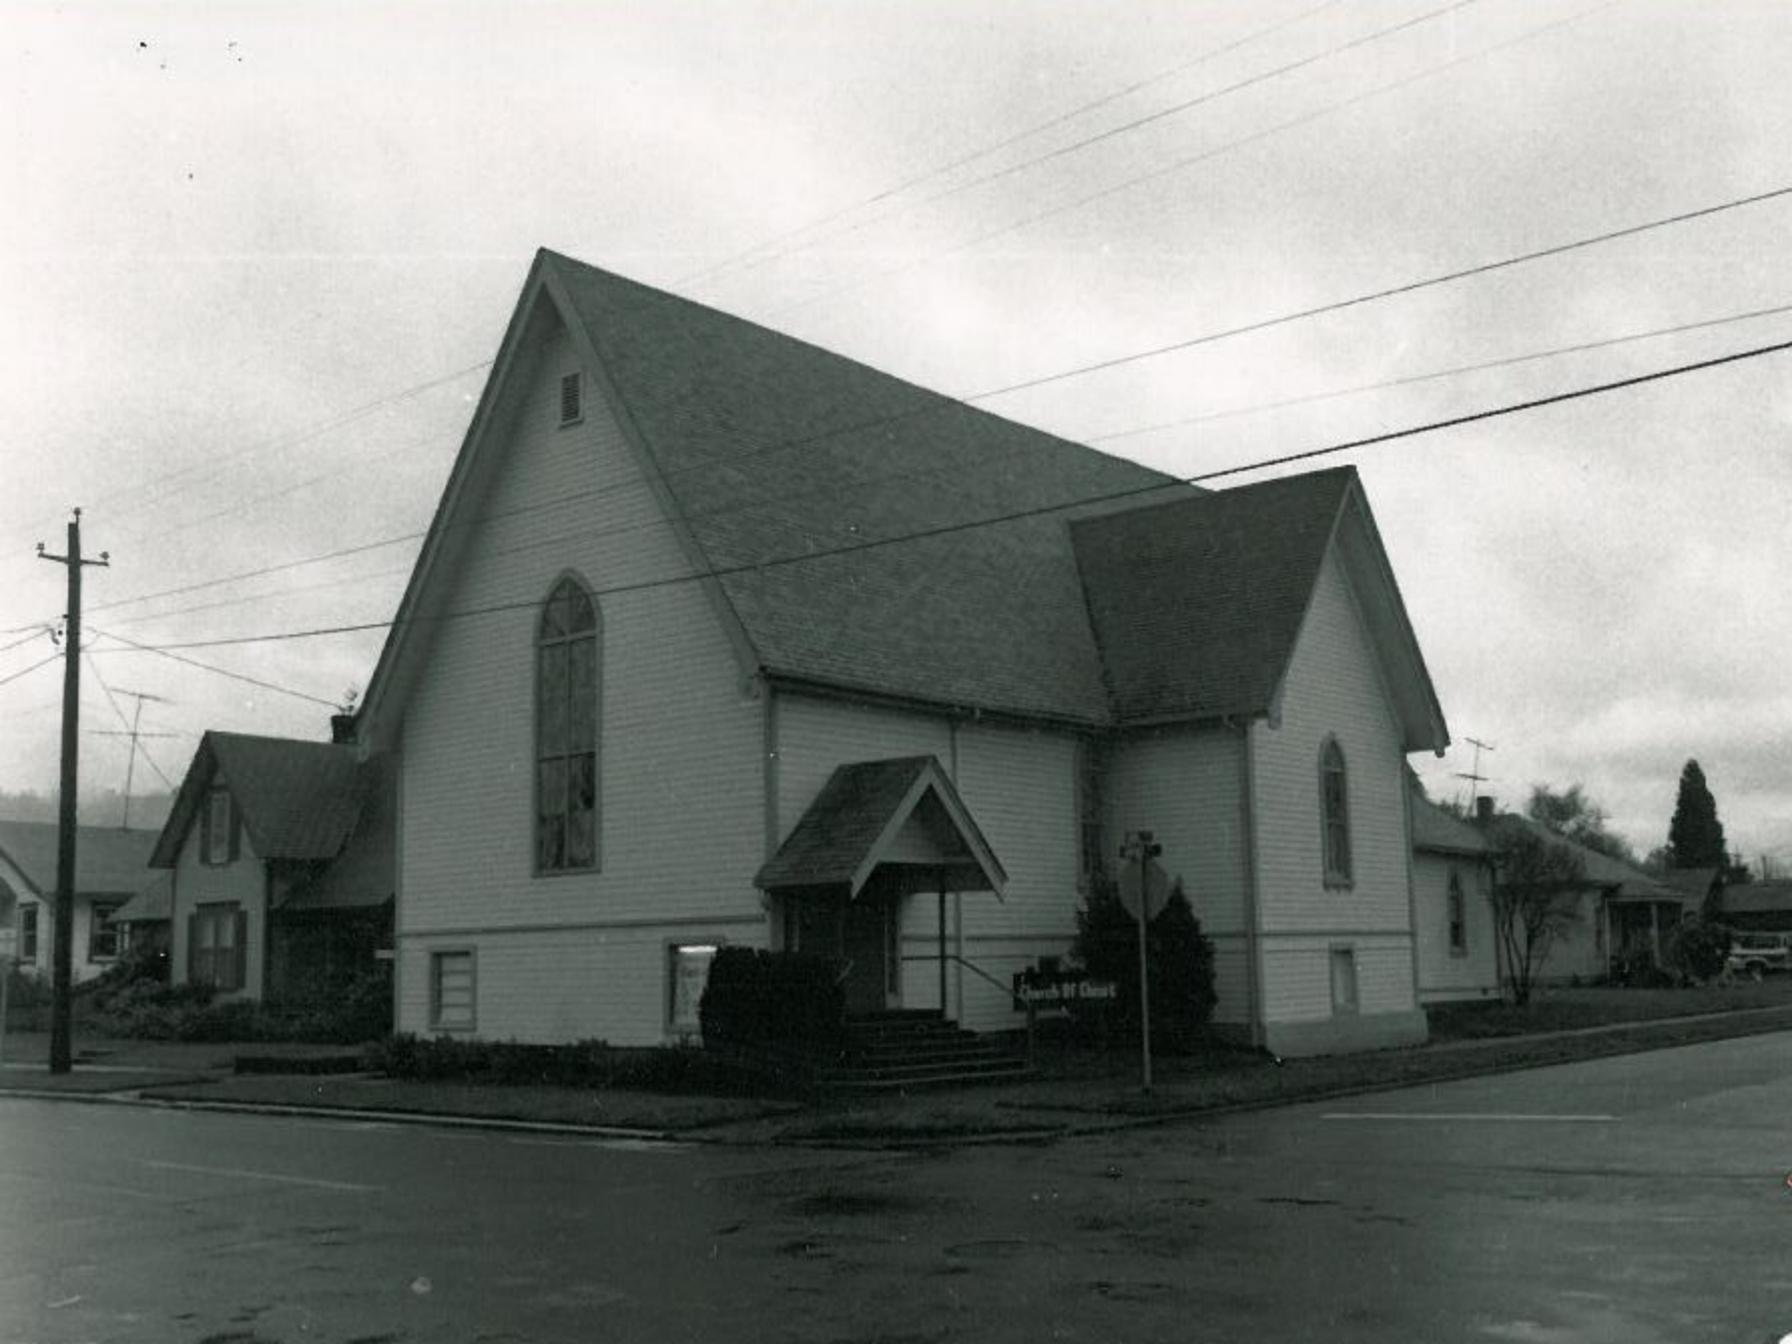
The east elevation is similar, except for a double-hung window that occupies the place of the entry doors. The apsidal projection has a lower hip gable roof. The addition has pointed arch windows containing two/two, double-hung windows and multi-light transoms. The north end of the nave on the north contains a large pointed-arch stained glass window and a square window in each basement corner. Vertical trim boards located halfway between the gable end and the transept indicate the size of the addition to the nave.
