STATE OF OREGON INVENTORY
OF HISTORIC PROPERTIES
State Historic Preservation Office
Oregon State Parks, Salem, OR 97310

County Linn
Ranking _____
Name
(Common) _____
(Historic) _____
Address 193 West Vine Street
Present Owner Dennis A. and Terezija Edgerly
Address 193 West Vine Street
Original Use Residence
Date of Construction 1904
Map Reference Number 23

193 West Vine Street

Map Reference Number: 23

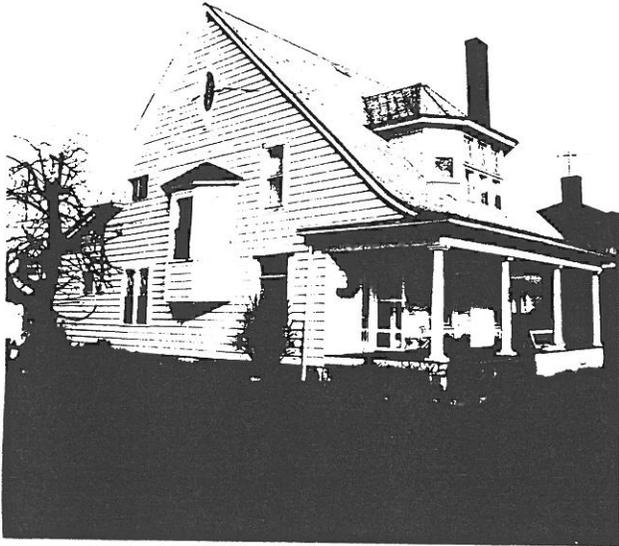
Colonial Revival details appear on this two and a half story residence with a square floor plan. The building has a salt-box shape with a front porch where the roof drops down over the first floor. The porch has four Tuscan columns and a new door that is framed by fluted pilasters, a cornice, and multi-light sidelights. On the right side of the porch there is a new exterior brick chimney with flanking one/one, double-hung windows. In the center of the roof there is a five-sided hip roofed dormer. In the front there are three double-hung windows below multi-light windows. On each side there is a double-hung window with a multi-light upper sash. The chimney punches through the porch roof and rises to the right of the dormer. Two corbeled chimneys located at the center on each side of the ridge have been removed.

The west elevation features an oriel window between the first and second floors with three double-hung windows on each side. Centered above, at the attic level, there is an oval window with four lights and keystone-like decorations. On the left side of the first floor there is a pair of double-hung windows with upper sashes containing diamond-shaped leaded glass, and on the right there is a large one/one, double-hung window with a short upper

sash. On the second floor there is a small horizontal two-light sliding window on the left and a double-hung window on the right. There are returned eaves and the verges are kept close to the building. Off the rear there is a one-story shed roofed addition with a single light window.

The rear elevation has a gable dormer with a two-light window. The addition runs along the rear featuring two windows and a door. There is a hip roofed wing at the left that is integrated into the larger shed roof addition.

The east elevation on the first floor has three one-light windows on the left, and on the right three double-hung windows with upper sashes containing diamond-shaped leaded glass. On the second floor there are two double-hung windows on the right and a single double-hung window on the left. At the attic level there is a large new three-light window. There are returned eaves with the verges held close to the building and the roof bells out over the porch. The entire house is clad with horizontal siding.
